Performance of the Tin-Free Antifouling Coating International *Ecoloflex* in DSTO/RAN Trials

Maritime Platforms Division
Defence Science and Technology Organisation

DSTO-TR-2203

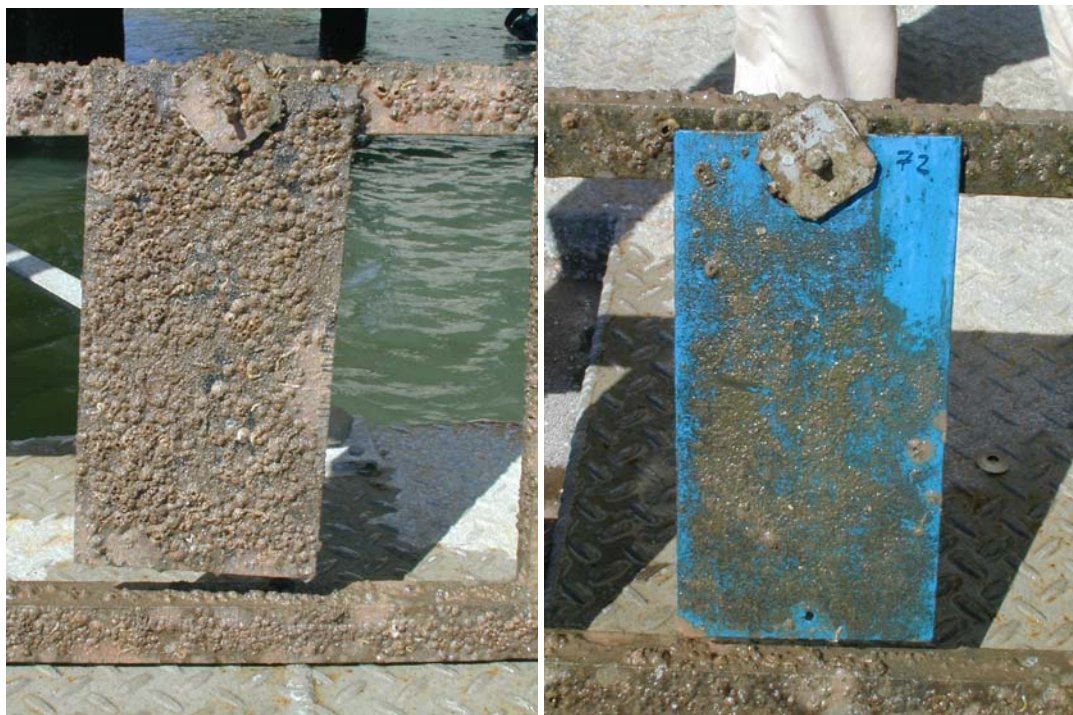
Figure 2: Test panels on Cairns raft, 12 May 2000: left, control panel after approximately 3 months immersion; right, Ecoloflex panel after 33 months (first immersed 14 August 1997)

Ecoloflex panels were immersed on the raft at *HMAS Cairns*, Trinity Inlet, Cairns, in August 1997. When inspected in May 2000, the panels were predominantly covered by a thick slime, unlike the control which was heavily fouled by barnacles and other fouling species (Figure 2). Several barnacles and bryozoan colonies were present on the surface of the *Ecoloflex* panels, but these were loosely adherent and easily dislodged.

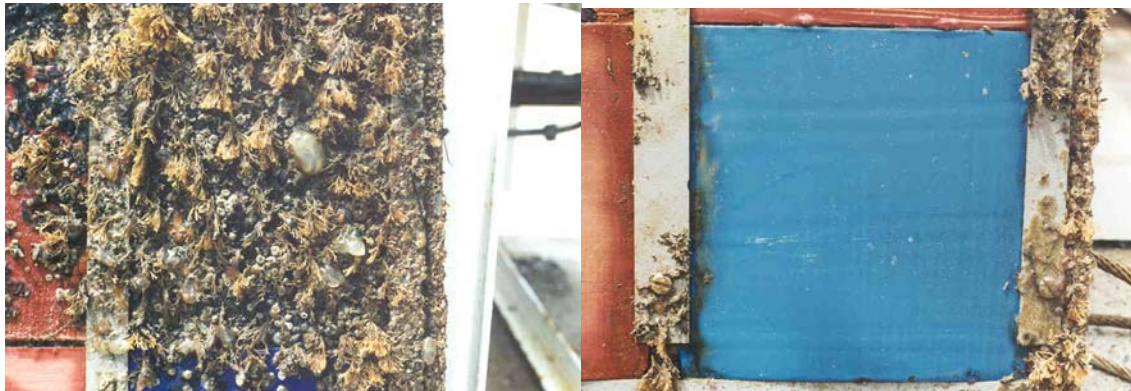
Figure 8: Ecoloflex panel (right) and non-toxic control (left) after static immersion during 1996/1997 rotor trial

In this trial, one panel of each pair was also suspended under Breakwater Pier for 10 weeks from September until December 1997. At the end of this period the *Ecoloflex* panel remained completely free of macrofouling, whereas the non-toxic control panel was heavily fouled by a diversity of fouling organisms (Figure 8).

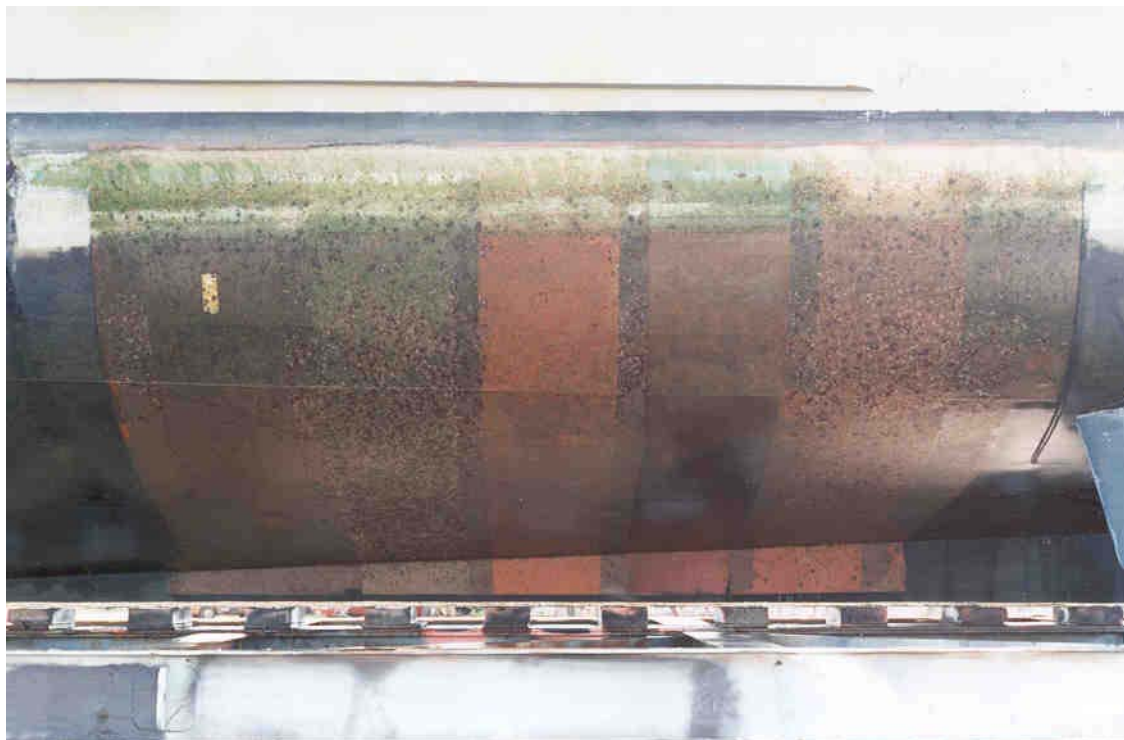
Figure 9: Port side midships test strips on HMAS TOWNSVILLE at completion of trial after 31 months

Although *Ecoloflex* was not one of the coating systems tested in this trial, the results are of value as a base for assessing antifouling performance on vessels based in Cairns. At the completion of this trial, after 31 months, all five coatings tested had fouled (Figure 9); all were fouled by green macroalgae near the water surface, and all but one were also fouled by macrofouling animals deeper down.

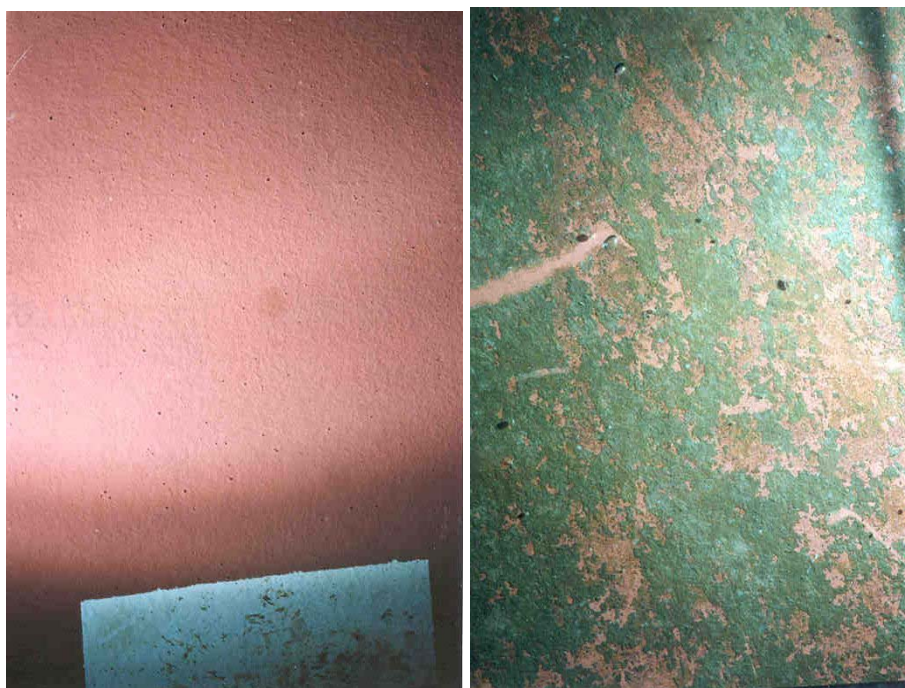
Figure 10: Underwater photographs of Ecoloflex strip on HMAS BENDIGO in January 1995 (left) and October 1997 (right) showing only slime

The first inspection of the test strips after the trial commenced on *HMAS Bendigo* in November 1993 was by divers in January 1995, and this showed the *Ecoloflex* coating to be in pristine condition (Figure 10). The more detailed inspection shortly after this, at the docking in Darwin in February 1995, confirmed the superior performance of the *Ecoloflex* system over the other five systems (Table 3, Figure 11). A second diver inspection in October 1997 found only slime on the *Ecoloflex* surface (Figure 10).

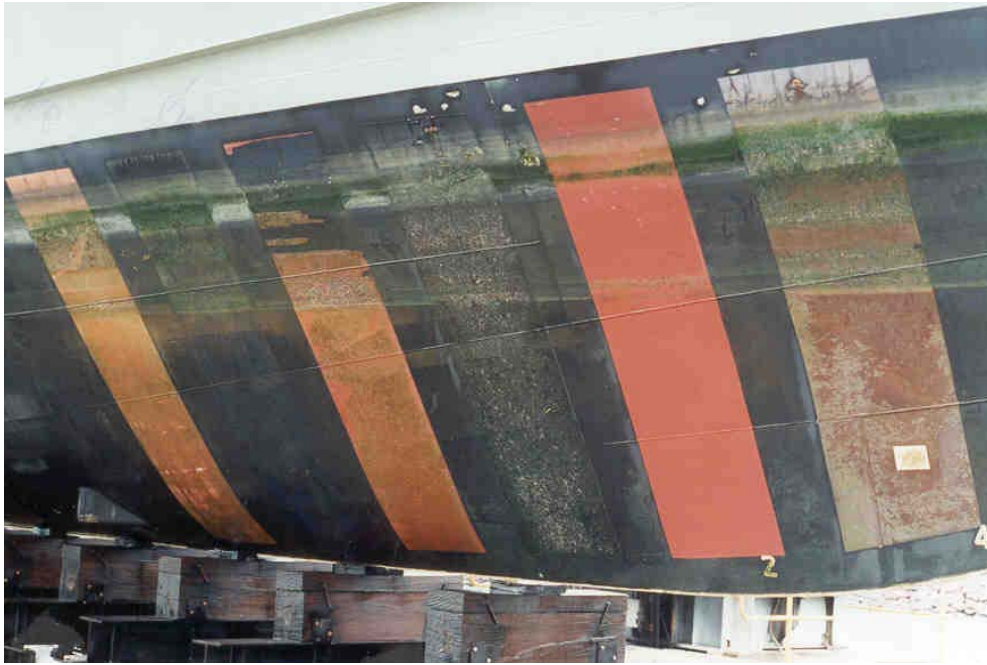
Figure 11: Starboard side strips on HMAS BENDIGO, February 1995. Ecoloflex strip is second from right.

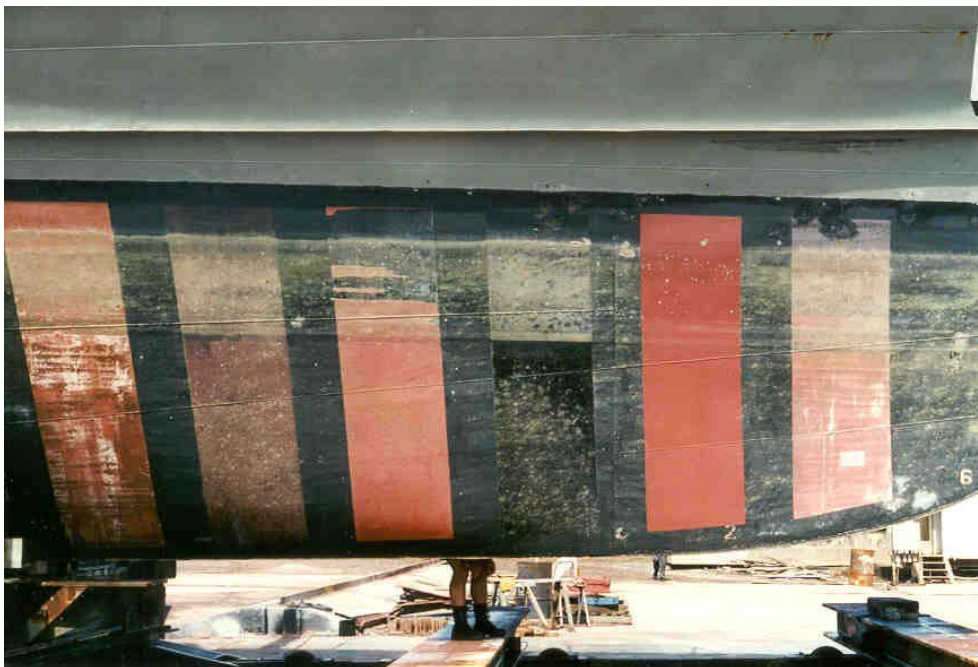
Figure 13: Starboard side strips on HMAS BENDIGO, April 1998

Unfortunately the timing and nature of the emergency docking of *HMAS Bendigo* in January 1998 did not allow for a detailed inspection of the test strips. However, a photograph taken shortly after the docking clearly shows continued good performance of the *Ecoloflex* system (Figure 12). At this docking the underwater hull, including the test strips, were high pressure washed. Continued good performance of the *Ecoloflex* was evident at the final inspection in April 1998 (Figure13).

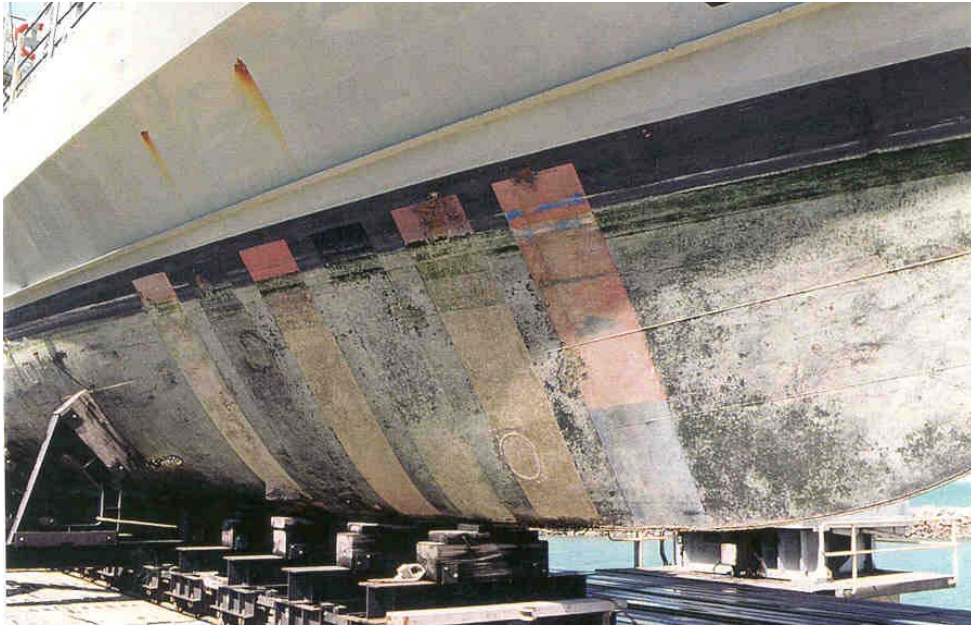
Figure 15: Starboard side strips on HMAS BUNBURY, May 1998. Ecoloflex strip is first from right.

DSTO staff were unable to inspect *HMAS Bunbury* at the docking in Darwin in May 1998, which preceded the premature removal of the test strips. However, the hull surveyors, G.A. Glanville & Co (Naval Architects) Pty Ltd, provided a brief report and photographs of the trial areas. The photographs (Figures 15, 16) show the *Ecoloflex* system to be performing effectively, and the report includes the comment:

“At the waterline green weed/slime coated all the strips with the exception of the 1st Strip on Stbd and 5th Strip on Port.”

These strips were the *Ecoloflex* strips.

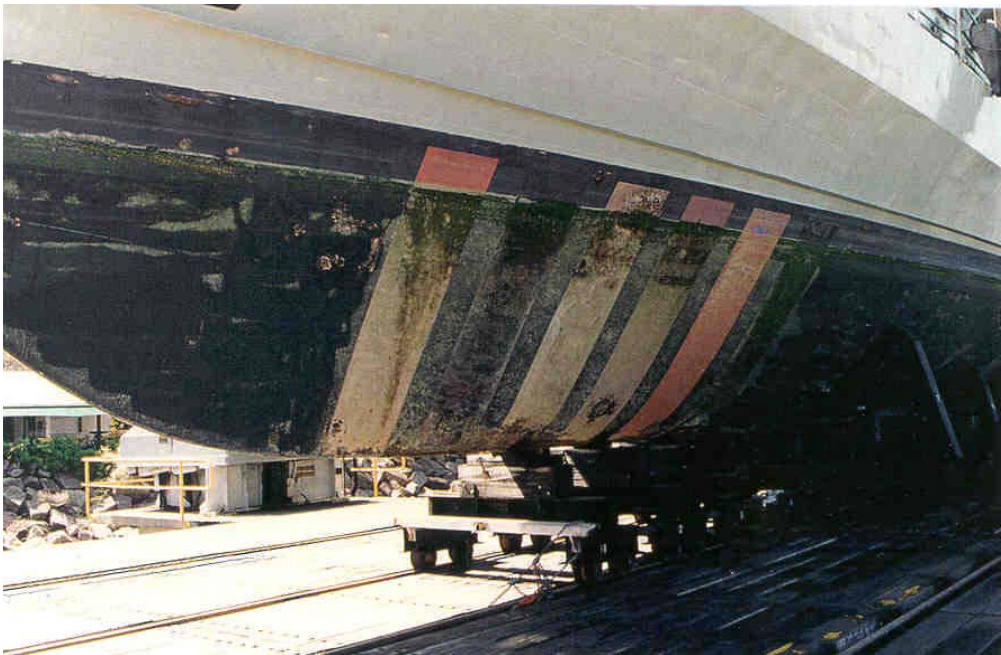
Figure 16: Port side strips on HMAS BUNBURY, May 1998

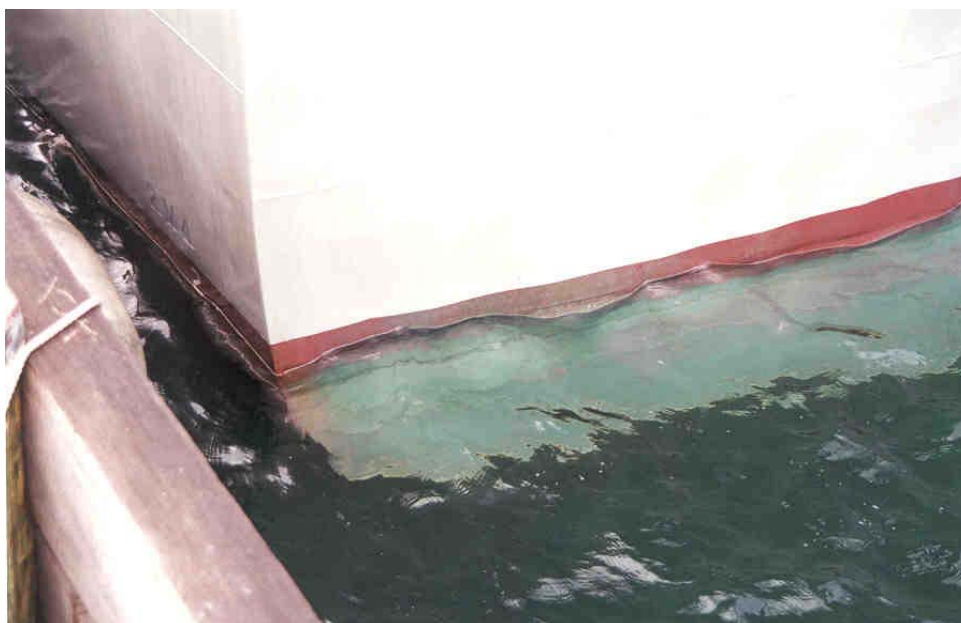
Figure 21: Forward port side of HMAS GERALDTON, Garden Island WA, April 2000

Figure 22: Transom of HMAS GERALDTON, Garden Island WA, April 2000

Photographs taken of the hull of *HMAS Geraldton* from alongside in April 2000 showed no signs of fouling growth (Figures 21, 22).
